# PETERSON

MACHINE & SUPPLY INC.

## PROJECT OVERVIEW

### GREY LIGHTNING

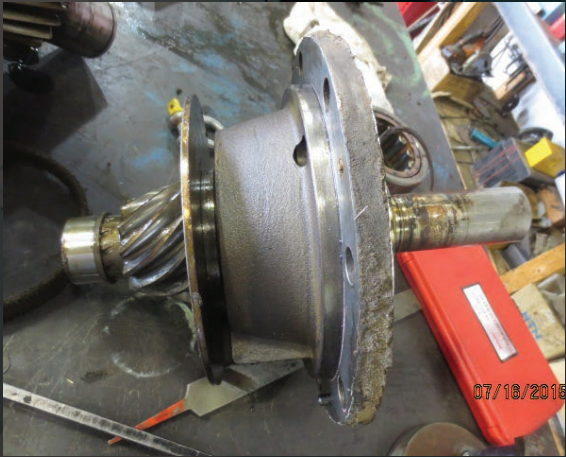
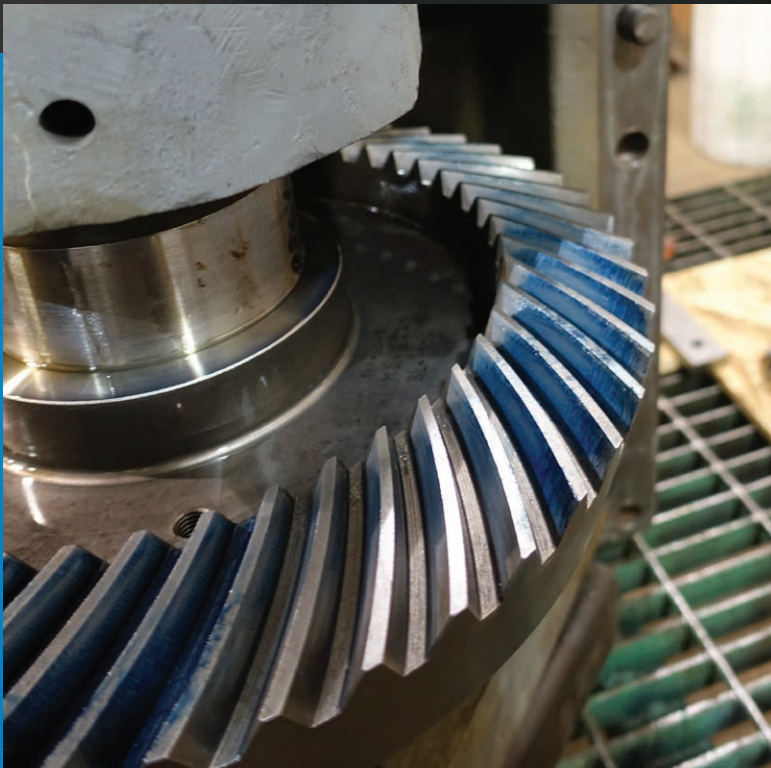
Upon disassembly and careful quality control inspection of the gearbox, the following faults were found:

- Crown and pinion gears damaged, the gears are obsolete and now unavailable from the manufacturer
- Seal fit on output shaft damaged
- Input bearing housing fit outside of allowable tolerance
